Subj: VAH-123 AAR ser 1-67A concerning A-3B BuNo 138917 accident  
occurring 5 April 1967, pilot PARKS

NAVAVNSAFECEN INVESTIGATION 54-67

a. The Accident. A-3B, BUNO 138917, assigned to HEAVY ATTACK SQUADRON ONE TWO THREE (VAH-123) and piloted by LCDR Richard Earl PARKS, USN, (b) (6) crashed (ALFA) on a snow covered mountain at the 7000-foot level, at 1432(U), 5 April 1967, eight miles southeast of Alturas, California. The four occupants of the aircraft sustained fatal injuries in the crash. The crash site was in a U. S. Forest Preserve, and property damage was limited to broken trees.

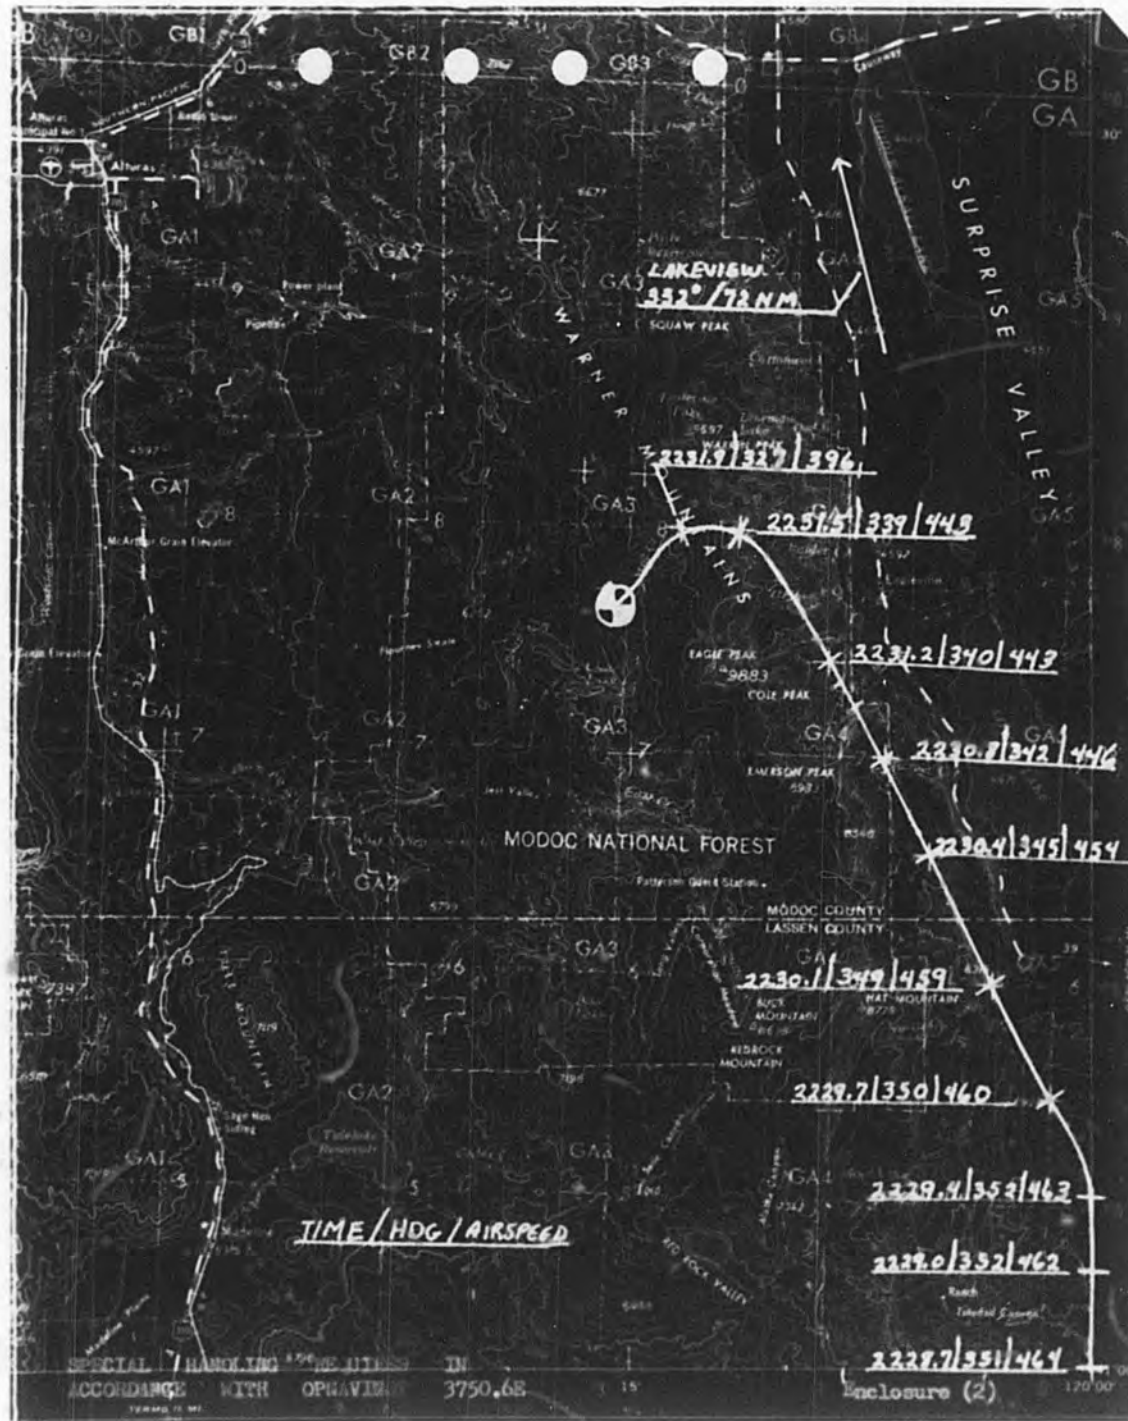
9 FLIGHT PATH

PROJECTED FLIGHT PATH TO IMPACT POINT

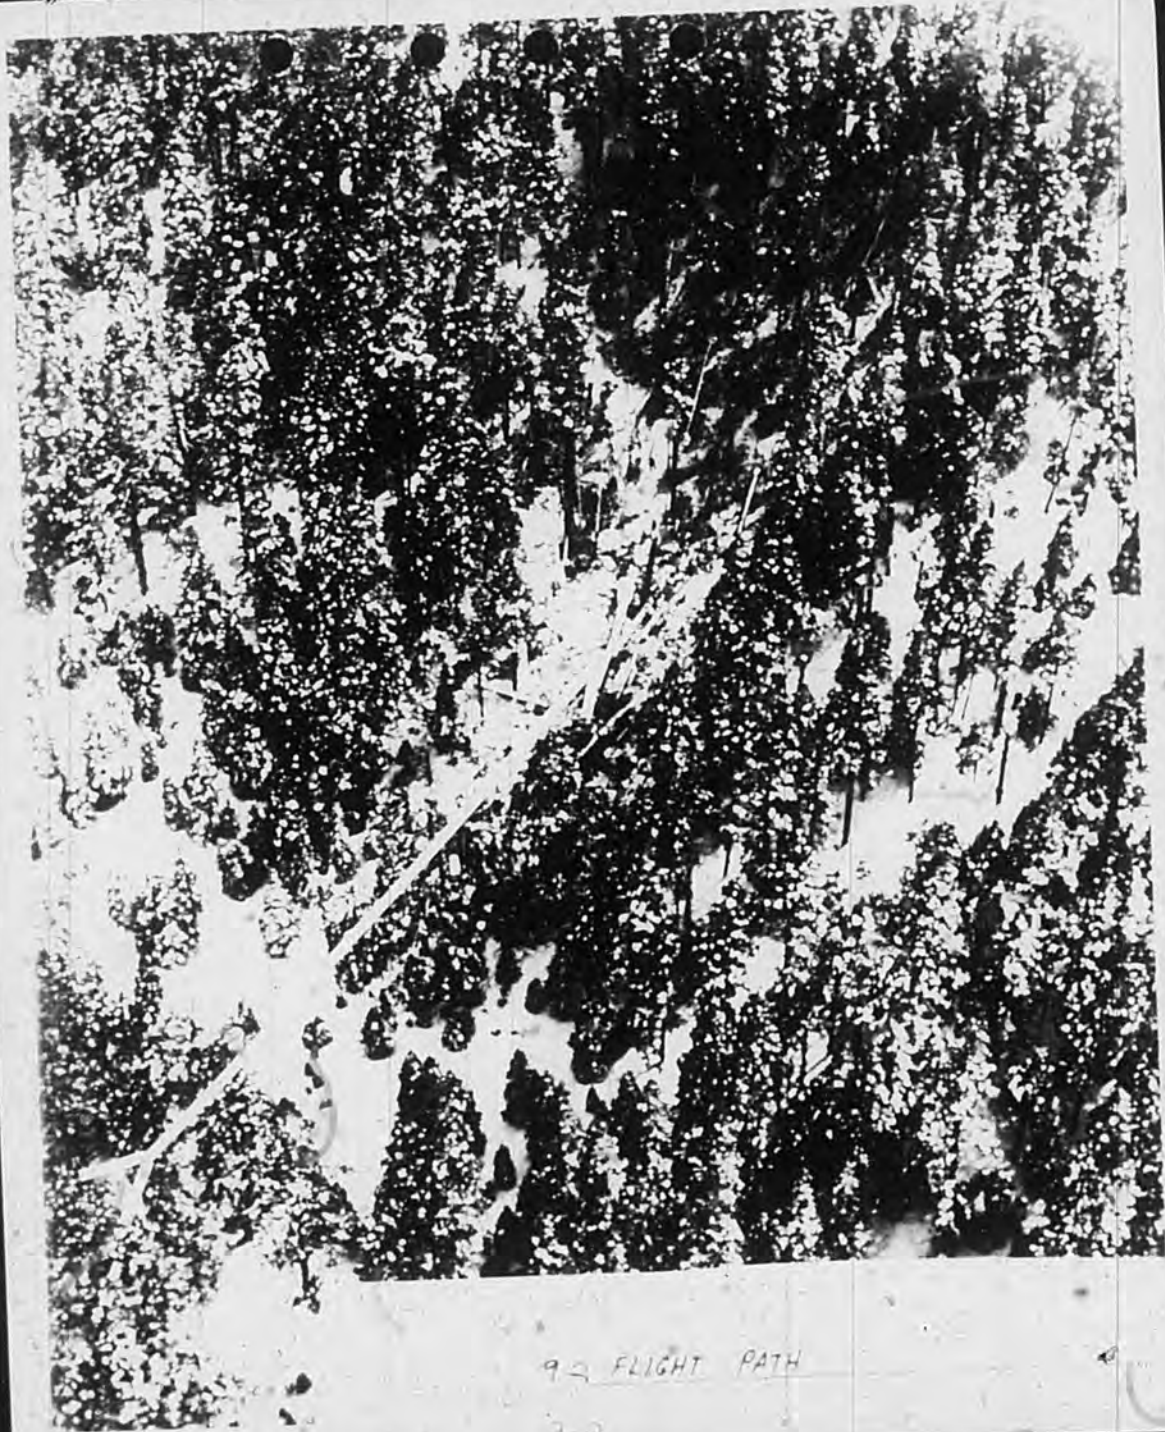
9-2 FLIGHT PATH

AIRCRAFT ENTRY ANGLE INTO IMPACT AREA

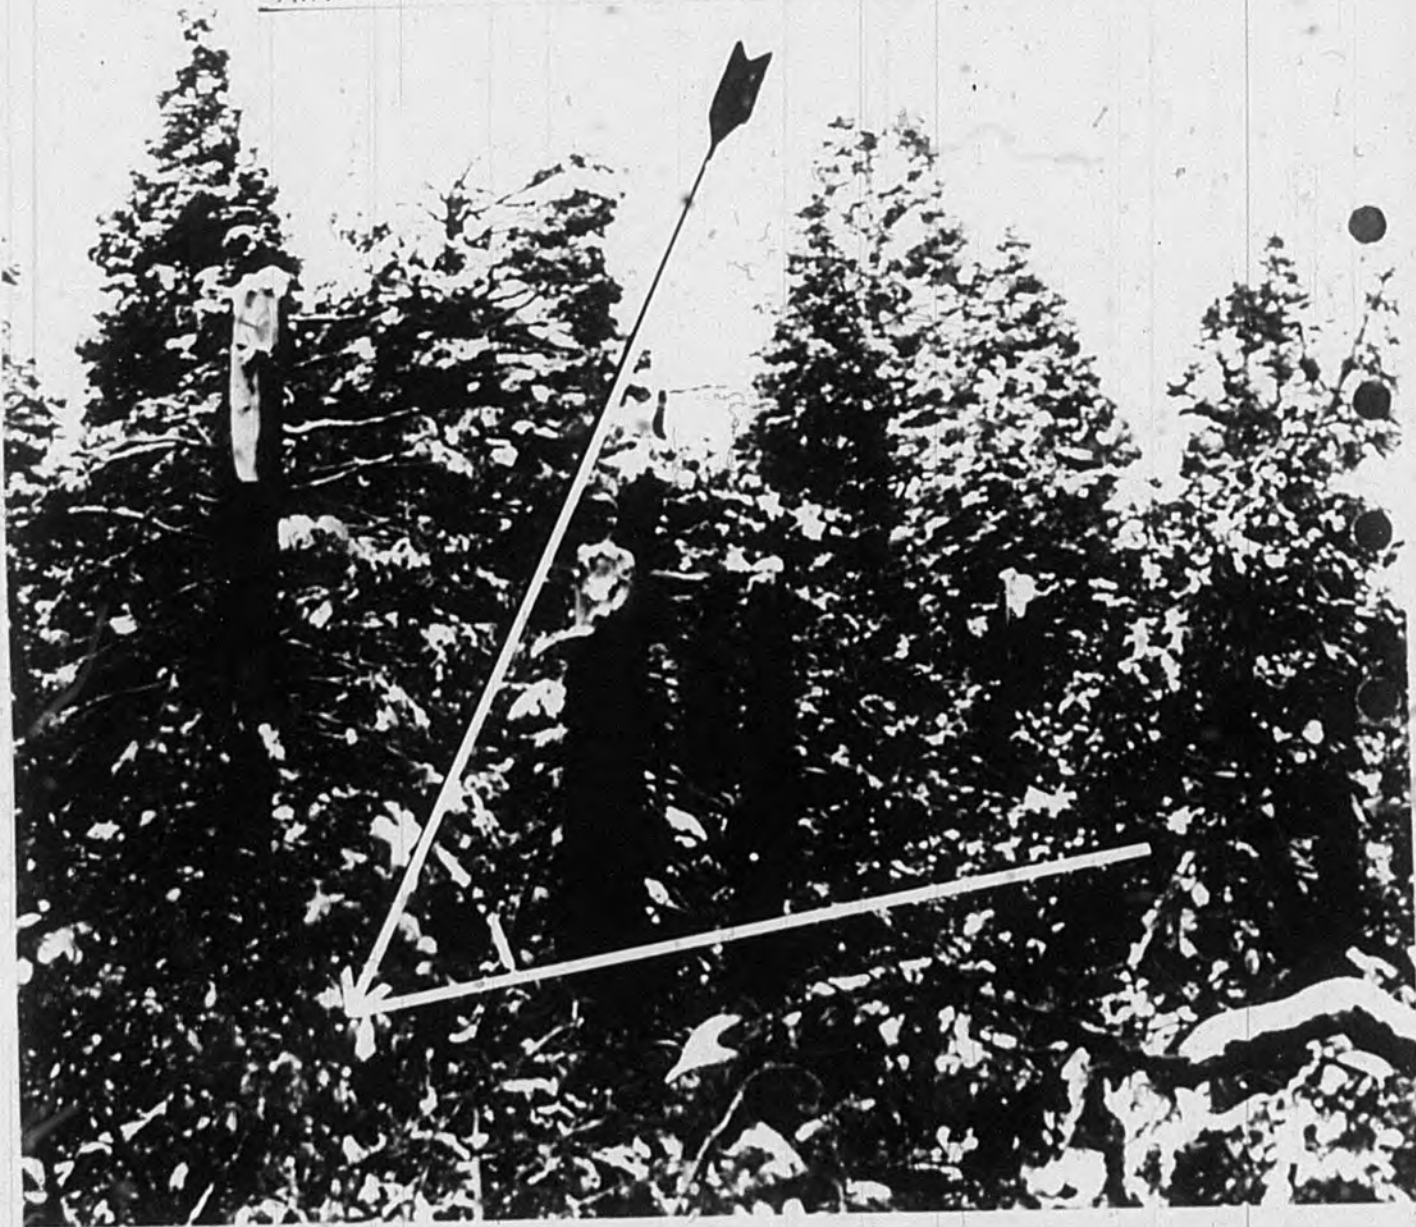
90° IMPACT ANGLE

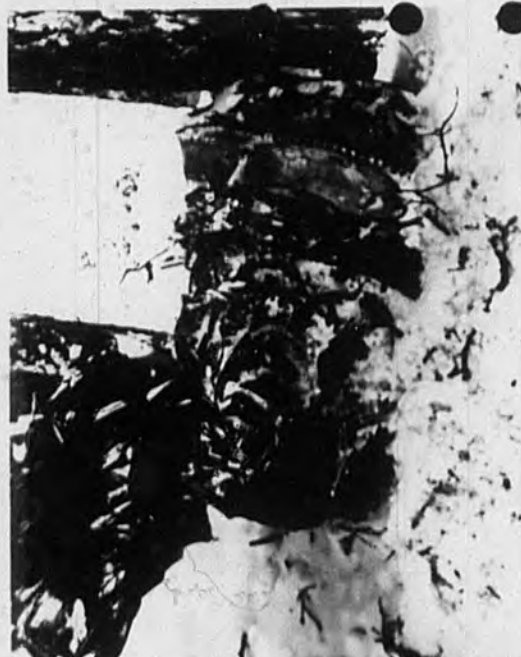
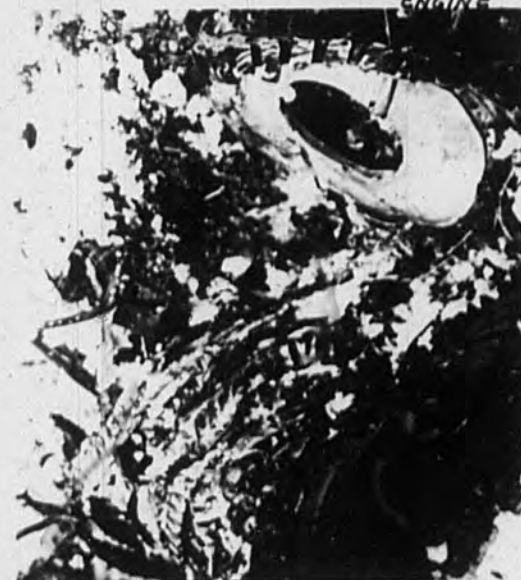
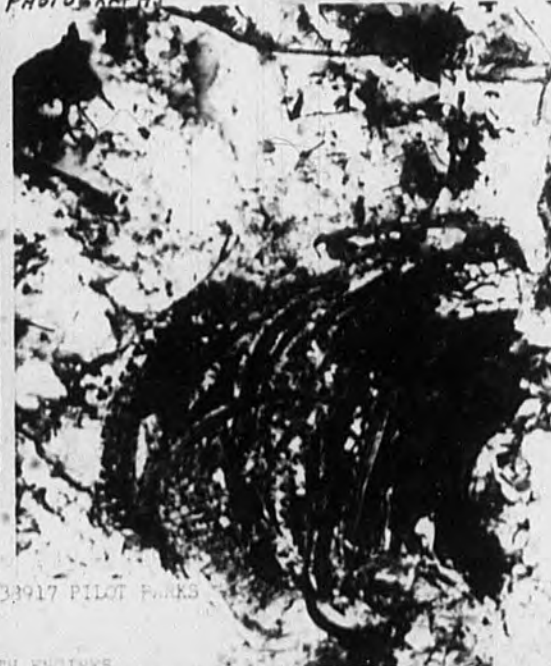
ENGINE

is reference (d). The port engine was concluded to be stopped or at low RPM at impact. The starboard engine was rotating at impact. No indication of malfunction was found in the engine accessories. The engines were incomplete as recovered. The first, second, third, fifteenth stages of the port engine compressor were missing; with the fourth and sixteenth stages unattached. The first five spacers from the N1 compressor were missing. The first and second stages of the starboard engine were missing; with the third, fourth, and sixteenth stages unattached. The first, second, and fourth spacers from the N1 compressor were missing.

ENCLOSURE ( 10 ) VIEWS SHOWING DAMAGE TO BOTH ENGINES  
SPECIAL HANDLING REQUIRED IAW OPNAVINST 3750.6E

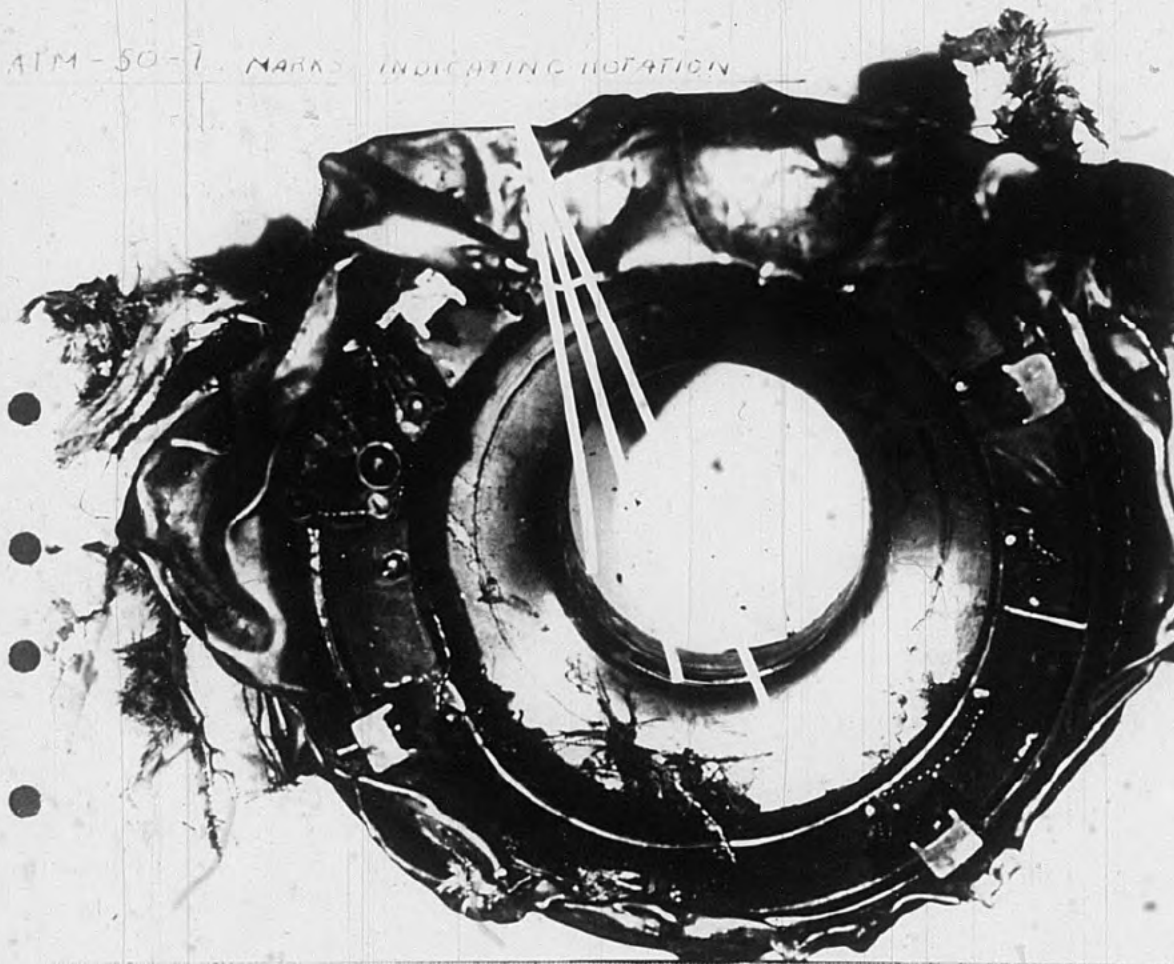
# ATM 50001

(a) Both air turbine motors (ATM) were turning at impact.

ATM-50-7 MARKS INDICATING ROTATION

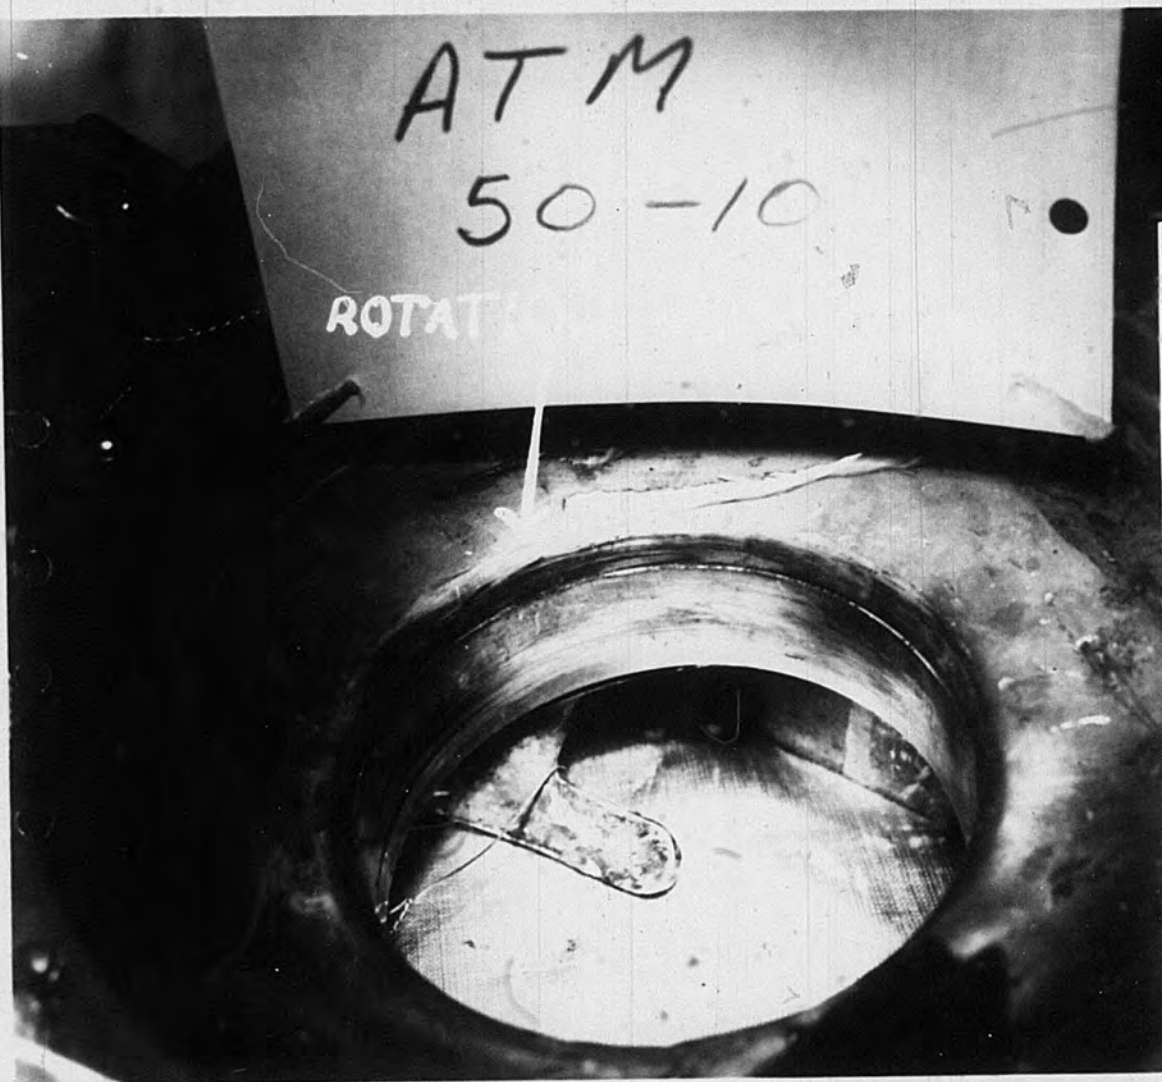
11-2 #2 ATM SCROLL

ROTATION
